1.0 Introduction

Gable ends are those upper triangular walls that rest on rectangular walls. They don't have horizontal eaves; instead their overhangs follow the slope of the roof. The triangles may be of various proportions and may be triangles with a section cutoff. Figures 1 through 6 show a variety of gable ends. The only gable ends for which retrofitting is addressed in this guide are those that include an attic. This guide does not address gable end walls where the room behind the wall has a cathedral or vaulted ceiling. Gable ends with attics that have headroom greater than 3' are the ones that typically need to be retrofitted. Fortunately, retrofitting is usually practical when this amount of headroom is available.

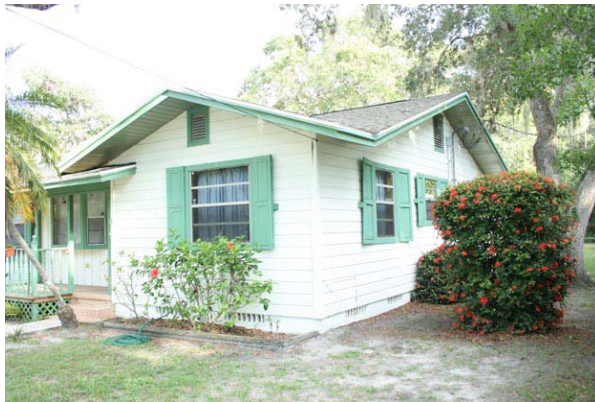
Figure 1.1 House with large and small gable ends

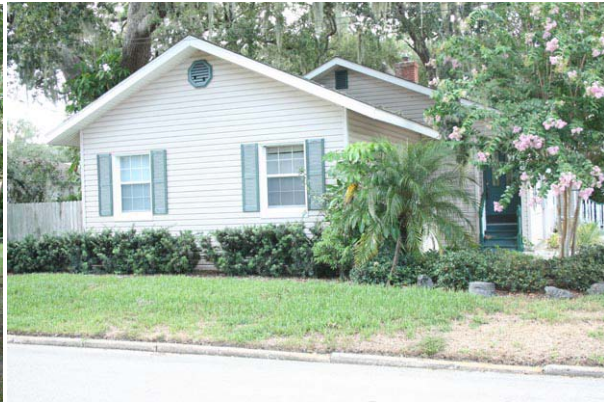
Figure 1.2 Large Gable at end with partially exposed gable where house is wider

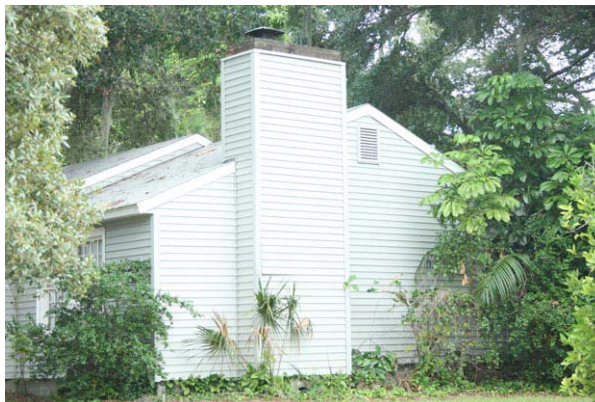
Figure 1.3 Gable end with attached chimney

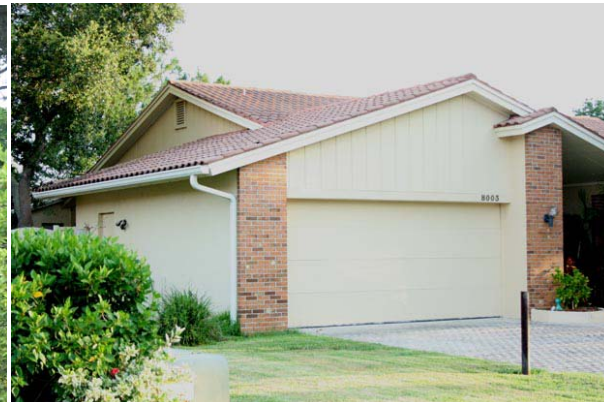
Figure 1.4 Cut off gable over garage with covered entry to side

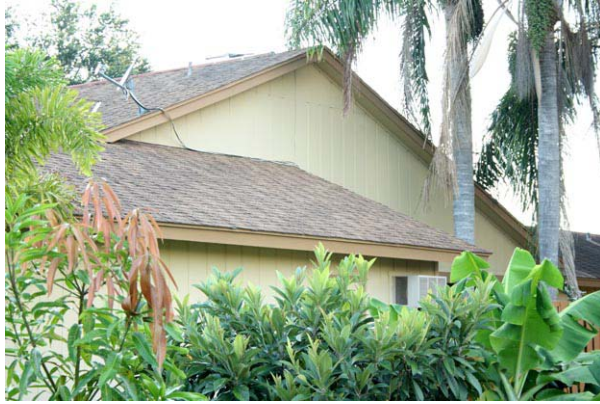
Figure 1.5 Gable end with intersecting shed roof

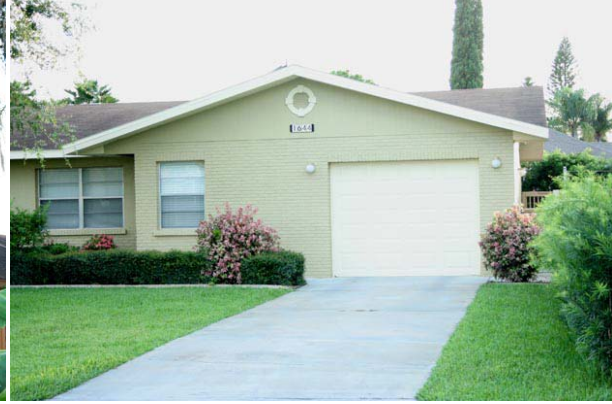
Figure 1.6 Gable end over garage and living area

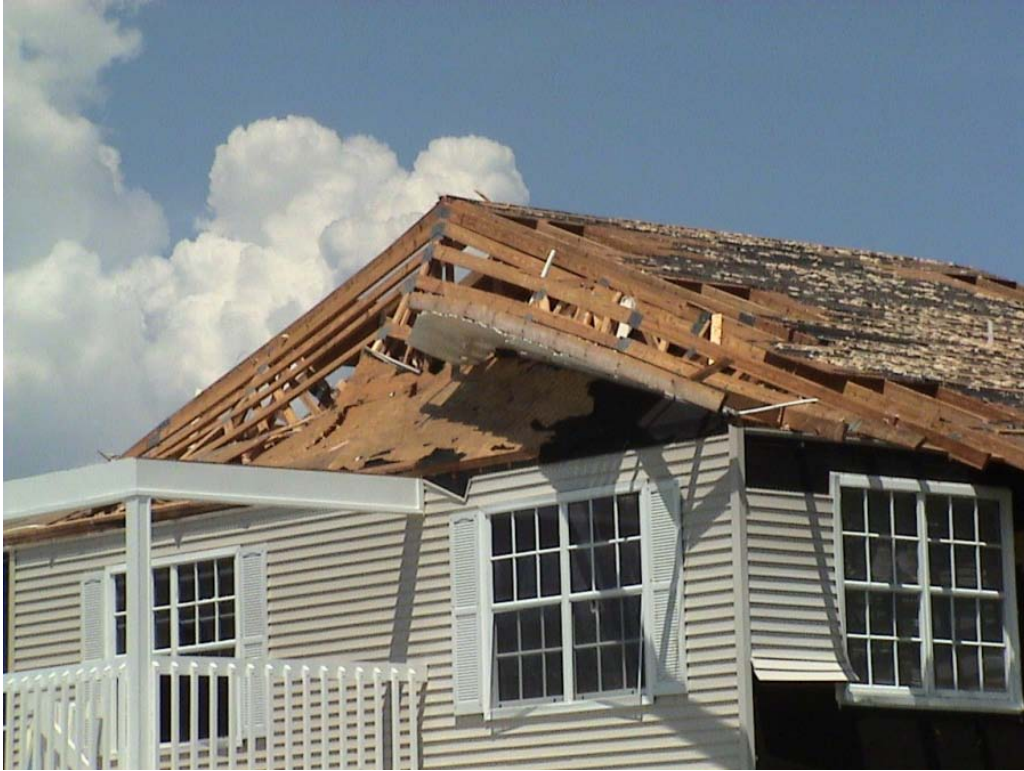
Figure 1.7 The most common gable end failure is one where the wall loses support along its top edge because sheathing is blown off at the overhang. The wall may fold outward (see cover picture) or be blown inward.

gable end that results in the gable wall losing its attachment along the top edge. This type of failure is shown in Figure 1.7. When winds blow against the gable end, they push it towards the interior of the house and push up on the roof overhanging the gable end. At the same time, the wind flowing over the top of the roof creates large negative pressures (uplift) on the roof sheathing. This combination of loads led to widespread loss of roof sheathing at gable ends and gable end failures in Hurricane Andrew, and has been frequently observed for older homes in other hurricanes. The second most common type of gable end failure is at the connection between the gable end wall and the rectangular wall below. It is rare that you actually find a failure that looks like the one shown in Figure 1.8 because usually the wall below fails and the whole end collapses as shown in Figure 1.9. The third potential weak link is the actual framing members that make up the gable end wall structure. In many houses, these members are simply the structural members of the last roof truss. Consequently, they are 2x4 lumber members installed with the wide flat part of the 2x4s parallel to the wall; the direction in which they are the weakest. In homes with rafters and ceiling joists, the gable end wall will typically be conventionally framed with 2x4s that are usually turned so that wind forces are applied to the narrow face of the 2x4s - the direction in which they are the strongest. However, they may only be toe-nailed to the rafters and ceiling joist.

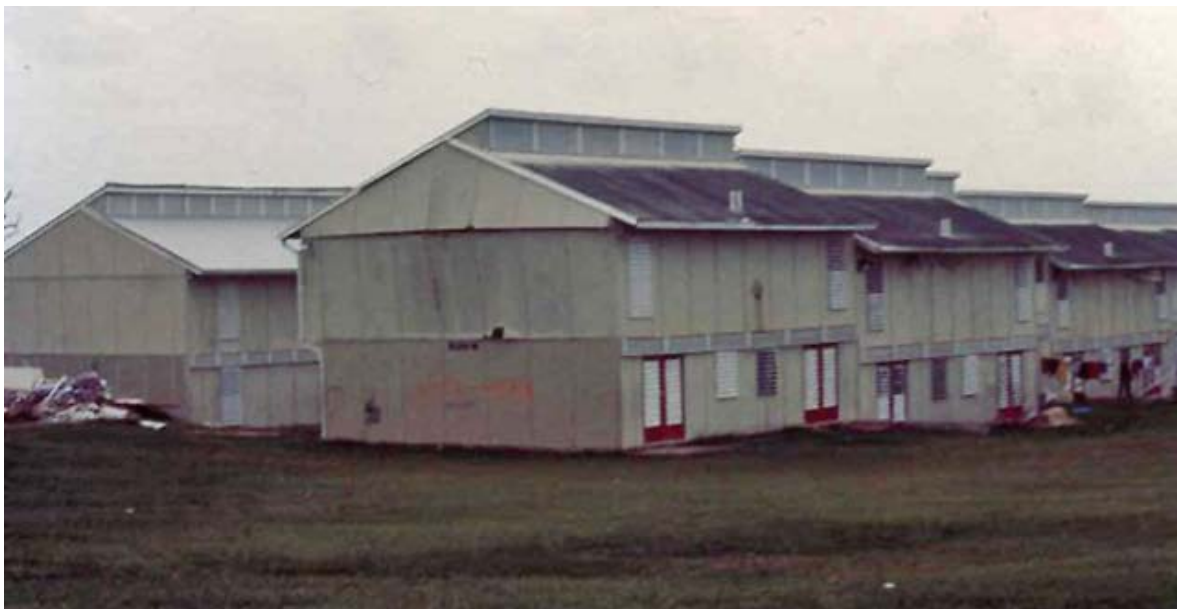
Figure 1.8 The second most common type of gable end failure is at the connection between the rectangular and triangular walls – Here the failure is just at the precipice of coming off the wall. It is the negative pressure of the hurricane that pulled on the gable end wall to compromise this connection when wind blew on other faces of the house to create that negative pressure.

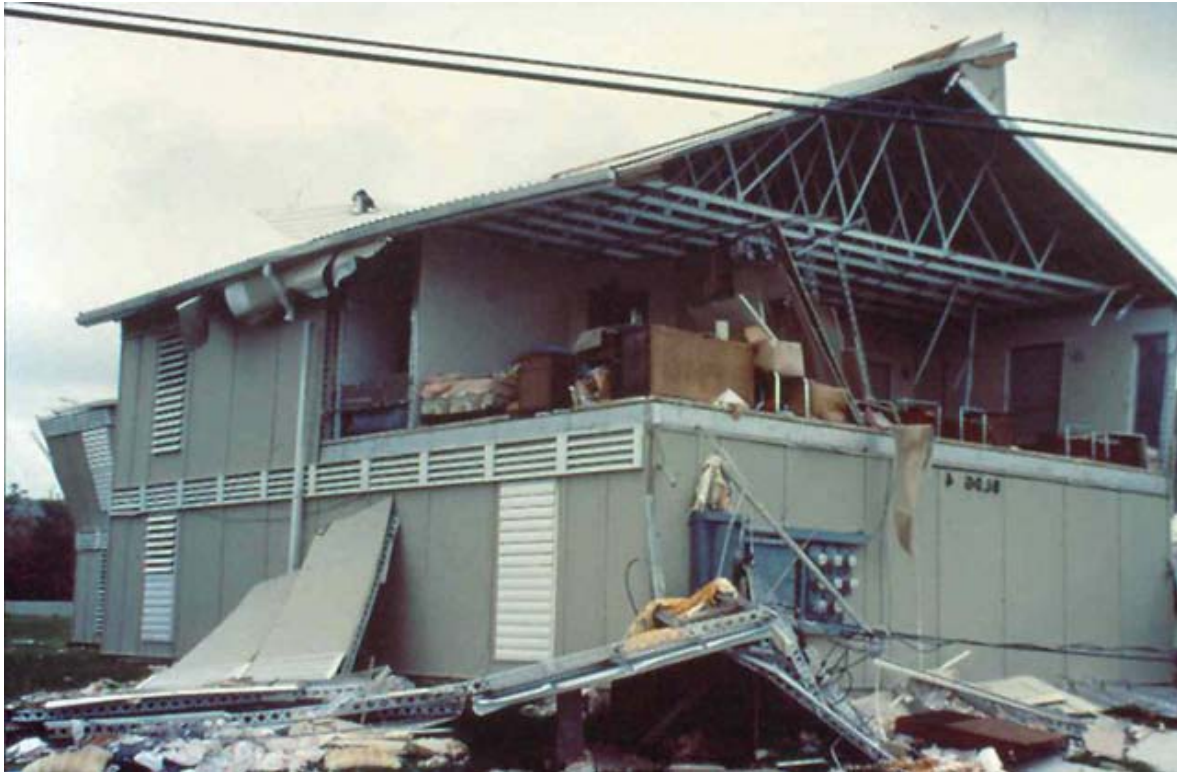
Figure 1.9 The more usual result of wall connection failures is a completely detached gable end wall and the wall below. This building is in the same project as that shown in Figure 1.8. These occupants were not so lucky. Probably all the possessions in this view were saturated with rain water.
