## 13.0 Other Retrofits to Reduce Risks of Damage and Water Intrusion

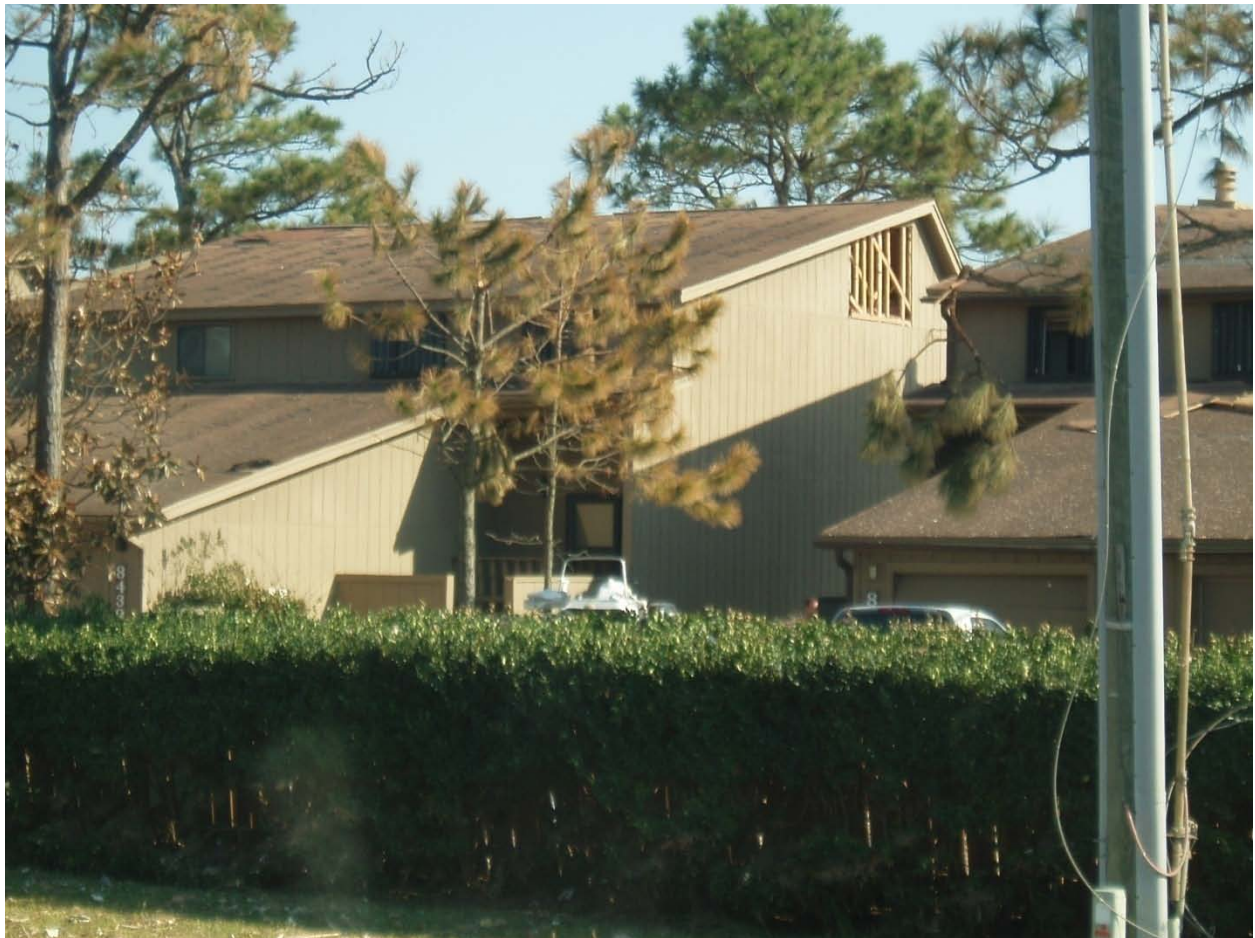
**Figure 13.1.** Missing siding pulled off by negative pressure or by wind that got into the house and pressurized it causing the siding to pop off. . If the wind shifted direction to blow rain into that opening, the damage to the rooms nearby could have been dramatic. Note plywood (or whatever) on the lower roof on the right.

***Gable end siding:*** The siding on the gable ends is critical to protecting your house. It makes the wall stronger and keeping water out of the attic. If it is deteriorated, water damaged, has delaminated or is not adequately fastened, then you need to consider siding retrofit measures. Figure 13.1 provides an example of inadequate attachment for which applying construction adhesive from within the attic might have prevented the damage.
