Gable End Bracing

Gable End Walls - Understanding the Risks:

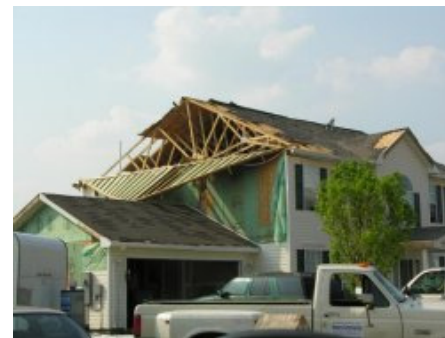
The most common gable end failure is one where the wall loses support along its top edge and is folded outward.

Roof Sheathing and Roof Overhangs: When sheathing is lost either because it was not fastened well enough or because the support of the overhang was inadequate, the gable wall loses support along its top edge and may collapse. This is what happened in the picture above. The roof sheathing was lost at the gable end and the wall collapsed outward. It could have been pushed in or pulled out. Keeping roof sheathing in place is also critically important to keeping water out of your house. If you have re-roofed your house and had the roof deck re-nailed following the recommendations in this guide, you have gone a long way towards solving the most common problems encountered with gable end roofs in hurricanes. Click on [Re-nailing the Roof Deck](#) for information on improving the fastening of your roof sheathing if you are thinking about re-roofing. If you have not had your roof deck re-nailed and are not planning on re-roofing soon, there are still

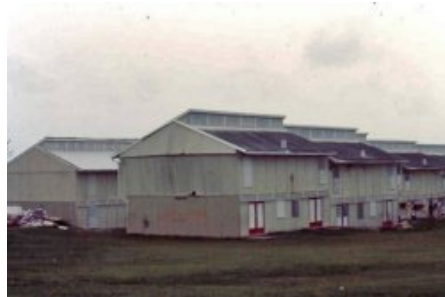
An example of the second most common type of gable end failure - the connection between the rectangular and triangular walls - It is rare that you actually find one that looks like this because usually the wall below fails and the whole end collapses.

Connections at the Base of the Gable Wall: In the photo below on the left, notice that wind pressure has pulled out the bottom of the gable end triangle and partially pulled out the rectangular wall below. A little more wind would likely have caused the whole gable end to come off the building thereby exposing it to a lot more wind damage and certainly water damage. The building on the right is typical of gable end failures where the whole wall falls off or gets pushed in. The occupants in the building on the left were very lucky compared to the ones in the unit shown on the right. The possessions you see in the photo on the right were doubtlessly saturated with water.

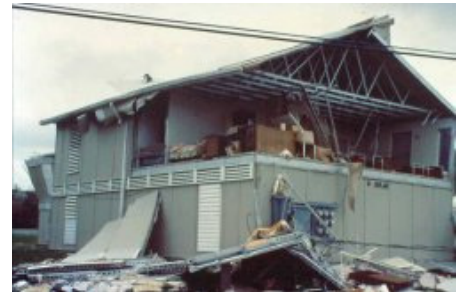
This is the more common look of a gable end failure when the triangular wall and rectangular wall separate

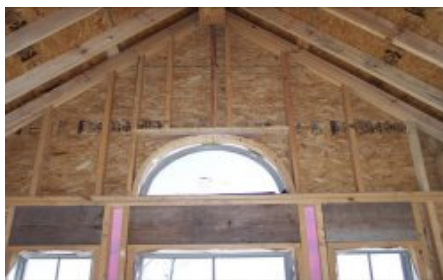
Gable end wall with cathedral ceiling - note the horizontal joint running across the wall just below the semicircular window. The arrows point to where this wall is apt to fail in strong winds. Because there are no continuous vertical members crossing the indicated line, that line becomes a hinge point where the wall is likely to buckle.

Gable Ends with Vaulted Ceilings: Gable end walls on rooms with vaulted or cathedral ceilings, while common (particularly when facing the coast or water), pose special problems for retrofitting. Unless special care was taken in the design and construction of these walls to provide the kind of bracing they need to stand up to strong winds, they are very likely to fail. The strongest construction, called balloon framing, is where studs reach all the way from the bottom of the rectangular wall up to the roof without interruptions. The other method, called platform framing, is where one set of studs is used from the floor up to the top of the rectangular wall and another set of studs is used from the bottom of the gable end triangle up to the roof. These two sets of walls are separated by the top plates of the rectangular wall. The result is a non-continuous wall without much ability to resist being pushed in or pulled out at the top plate level. You may well be able to determine if you have balloon or platform construction simply by pushing near the top of the rectangular wall. If it gives at all, it is the weaker kind of construction, platform framing. In this case, an engineer may suggest adding a horizontal beam across the wall at the top plate level.

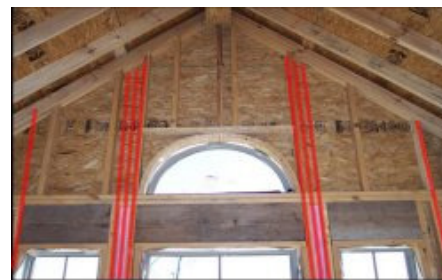
The red lines indicate where continuous wall framing members could have been used by the builder to avoid the weak connection between the rectangular wall at the bottom and the triangular wall at the top. A large continuous horizontal beam (probably a glue laminated beam) that is well anchored to the side walls would be an alternate solution.
