10.0 Implementation: Wall-to-Wall Connections for Masonry Walls Below

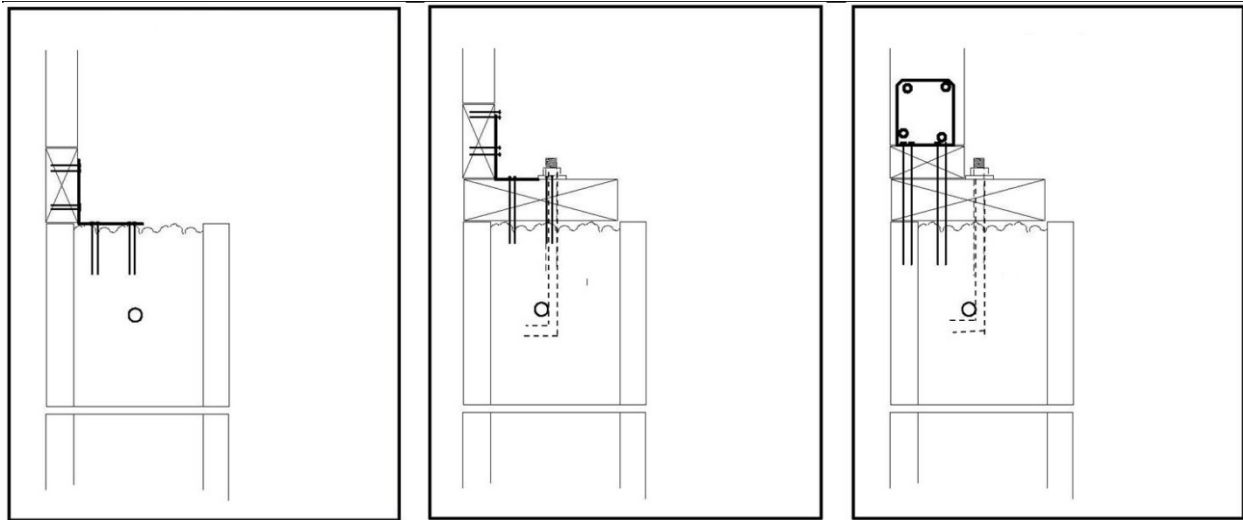
Fig. 13a – Truss gable wall over masonry wall

Fig. 13b – Truss gable wall with wood plate anchored to masonry wall below

Fig. 13c – Conventionally framed gable wall with wood plate anchored to masonry wall below

Figure 10.1. These drawings show the most common situations where the lower wall is made of masonry. Ignore the '12' shown in the Fig identifications.

Figure 13a shows the case of a gable end truss bearing directly on the masonry wall. Figures 13b and 13c show the gable end wall, truss or conventionally framed wall, bearing on a plate that is usually a 2x8.

See drawings b) and c) in **Figure 10.1**. This is a straightforward installation if the 2x8 plate is adequately connected to the wall by anchor bolts or straps that are effective and spaced close enough together. The 2x8 can be regarded as adequately connected if all of the following conditions are met:

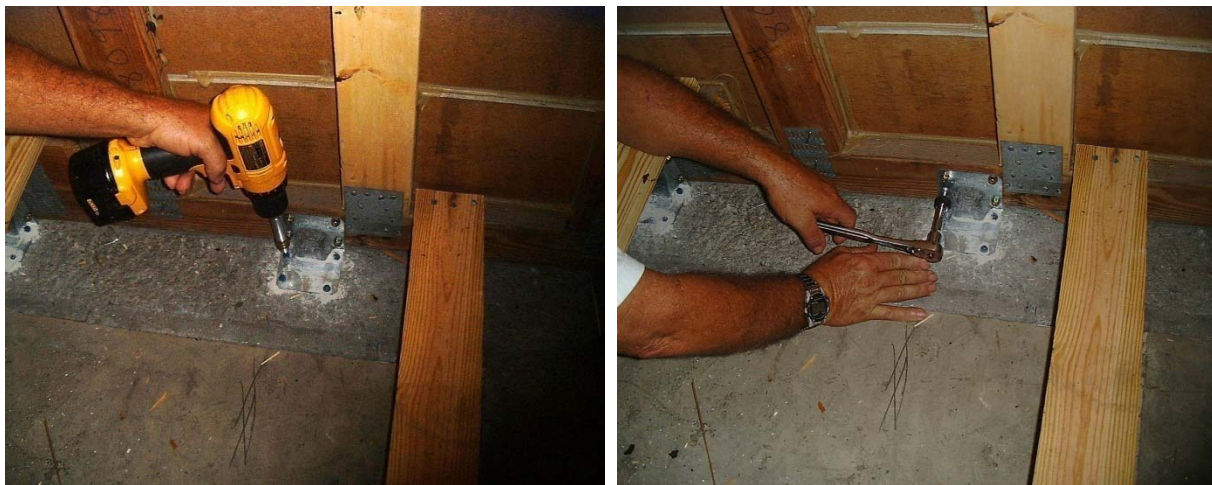
Figure 10.2. This shows an HGAM being installed directly to the top of the masonry wall. Here the elevation of the bottom chord was just fine as well as the grout in the concrete block being fine too.

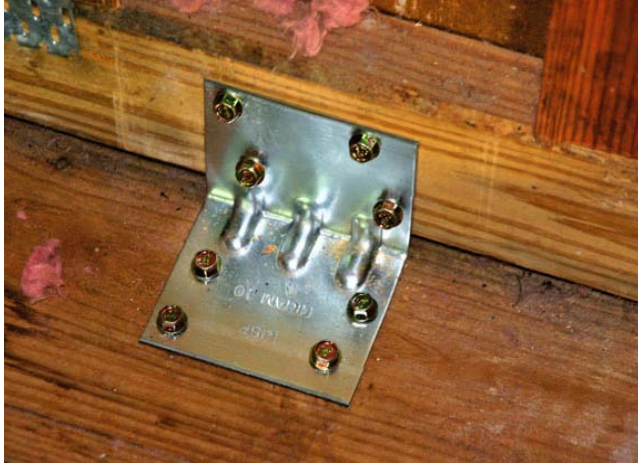
Figure10.2. HGAM right angle gusset bracket connected to 2x8 on top of masonry wall. Vertical fasteners can be attached just to the wood 2x8 using 1-1/2" wood or screws or optionally all the through the plate and anchored to the masonry wall using masonry screws.

Impediment and solution: The 2x8 plate is inadequately connected: In this case there are two solutions. The first is to disregard the connection between the 2x8 and the wall by making your retrofit connections through it and directly into the concrete below. You do that by using concrete screws that are long enough to penetrate the 1-1/2" thickness of the 2x8 plate, and penetrate the concrete to the depth specified by the HGAM manufacturer. That is the easy and perfectly good solution., Another solution is to anchor the 2x8 to the wall better independent of HGAM connectors. You can pretty easily anchor it better simply by adding 1/4" diameter masonry screws that penetrate at least 1-3/4" into the top of the concrete block wall. One such fastener should be placed within 12" of each existing or retrofit stud.
