12.0

Impediments to the Installation of Horizontal Braces

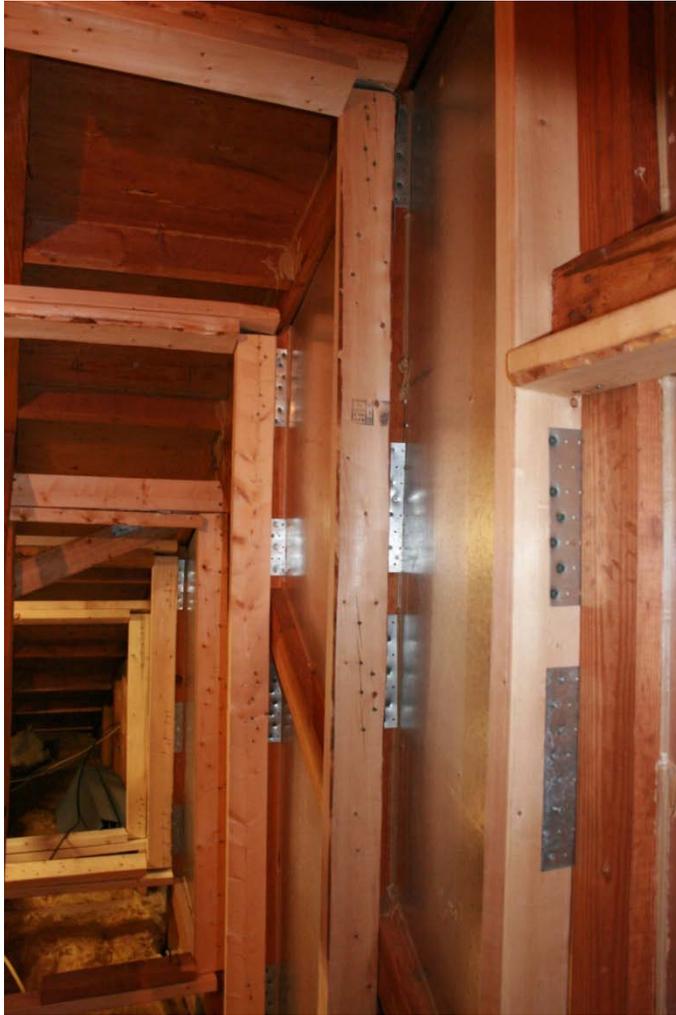
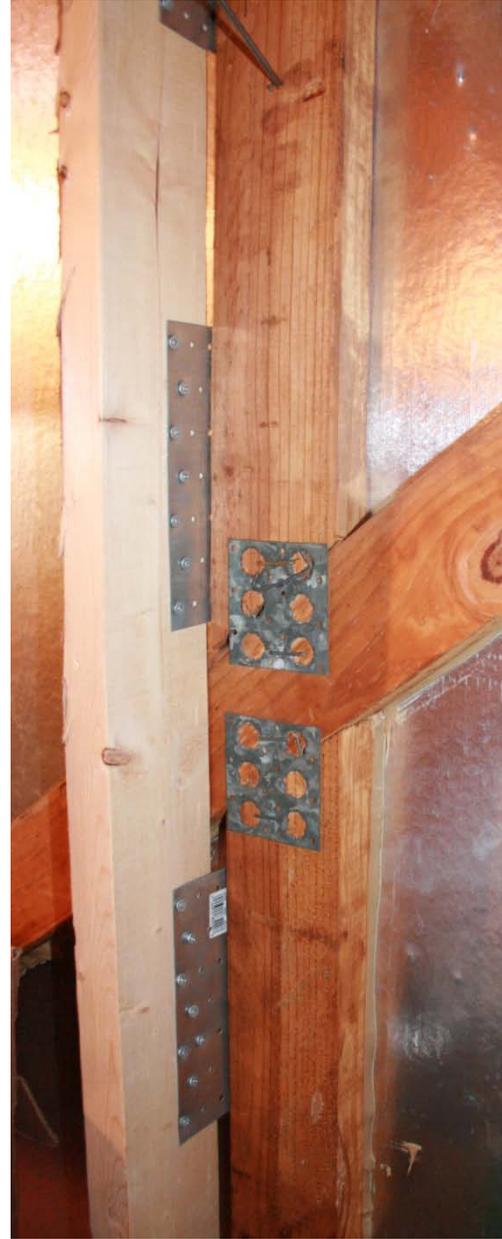
Figure 12.1. These show nail (nail, tie, mending) plates along the lengths of the retrofit and existing studs to bridge around webs on the truss.

The other work around is done by placing the retrofit stud against the outside of the existing stud. Then fasten nail plates to connect the two studs together. This is simple and does not require cutting notches. This nail plate method requires more fasteners. The requirements for attaching the nail plates and their spacing along the studs are indicated on Figure C104.3. Acceptable Simpson tie plates include TP37 and all that are wider or longer than the TP37. Acceptable USP mending plates include NP37 and all that are wider or longer than the NP37. The longer they are the easier they are to install.
