Porches & Attached Structures

Understanding the Risks:

Division of Emergency Management

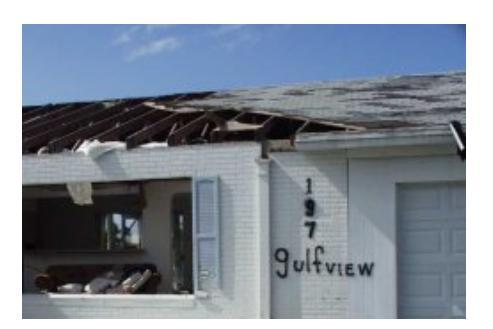
This porch on an older Florida house was closed in to make an extra room. A crane was used to lift up on the roof as part of a older homes. Note that the roof was just resting on the brick column with no anchor to hold the roof down.

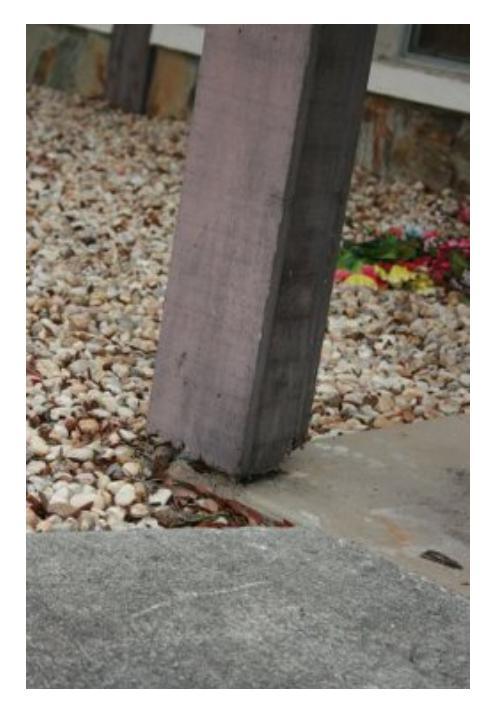
This shows a post with a weakened bottom and no clear indication of any uplift capacity. It is likely that there is a rod sticking up from the concrete that holds the bottom in position.

Wood posts, and particularly cedar ones, that have been exposed to rain are susceptible to water damage that will soften the bottoms of the posts to the point that nails holding the posts in their column base metal connectors are not very effective. Try poking with an ice pick, nail, or sharp screw driver at the bottom of the wood post at a height just below where the fasteners are installed to determine whether the wood is soft. If the wood is found to be soft, the post needs to be replaced. Alternatively, you can replace the connector with one that reaches higher up the post. What happens is that wood and particularly cedar can be so soft that it acts like a sponge to wick water up and eventually cause rot that may not be immediately apparent, but is there nevertheless. The nail holes used to fasten the column base connector to the post are frequently so close to the ends of posts that any water damage compromises the post's strength. Bottom of post deterioration can take place even where `dry bottoms', little platforms that raises posts an inch or so off the concrete, are present.

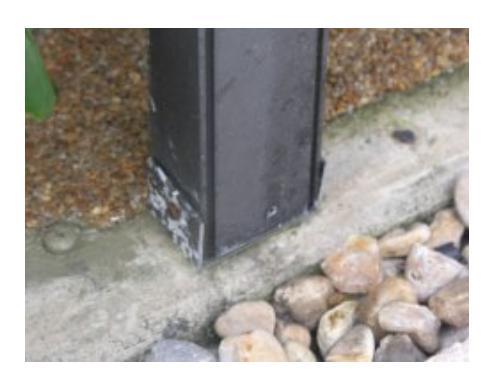
This column is held down by two rusty tech screws. The white is aluminum oxide,

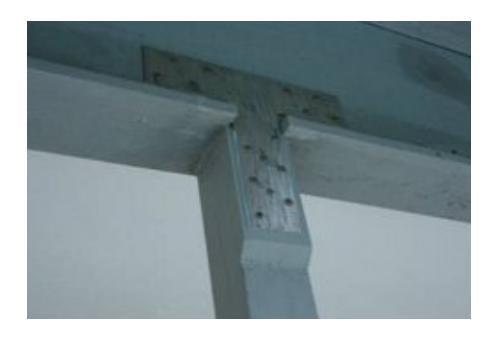
Connector added at the top of post where a spacer board was needed so that the faces of the post and the beam would be aligned. Connectors need to be installed straight to maintain their strength. (click image for larger version)

Tops of posts: One solution to the problem of assuring a good connection at the top of post is to add a strap from a post to the structure above. In many cases that structure above will be a beam. Existing column caps or other connectors may be hidden from view. There are a variety of connectors that can be used including column caps, flat straps, and tee connectors. The photo below shows a nice solution where the column cap connector was inadequate so a hefty tee strap

was fastened to the face of the post with the strap extending up to the face of the beam where it was fastened. Because the face of the post did not align with the face of the beam a spacer board was added to make a flush connection. The lengths of the screws into the post were selected to be especially long to compensate for the ineffectiv eness of the spacer board. Stainless steel straps and screws were used because the posts were just a few feet away from a swimming pool.

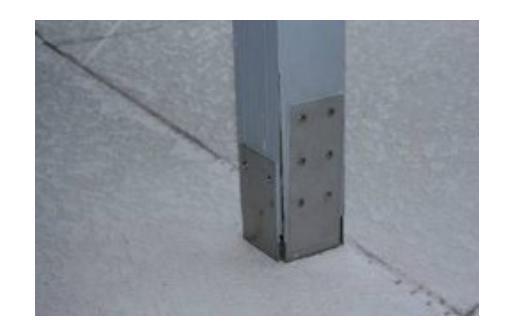
This shows a replacement connector with its dry bottom hidden. Here the distance from the concrete screw to the edge of the slab was an important consideration. (click image for larger version)

Bottoms of posts: Replacing column base connectors can be a challenge because it is difficult to install a new connector under the post. In most situations although beams may appear to run continuously and without interruption over the post, they actually probably are spliced together end-to-end over the post or if a beam is made of multiple pieces of lumber, one maybe spliced at the post where work is being done and anther beam runs continuously to the next post where it is end spliced. This means one cannot simply remove a post without supporting the beam above it by using shore posts. Two are required, one on each side of the existing post. The shores can be shimmed up so the original post can be moved aside enough to remove the original connector. Although this will lift the whole roof a little, it usually causes no damage. Next drill a hole for a hefty concrete screw and set the replacement column base connector in place with its dry bottom. Replace the column that was moved to allow the installation of the new base and tack it in place with a couple of nails driven a little ways into the post if it is loose. Finally, the shores can be removed and then permanent fasteners installed to connect the post to the connector.

For a connection to concrete, the concrete has to be at least 6" deep. When using large, say 3/8" to ½" diameter concrete screws, try not to drill the hole through the bottom of the concrete because that may chip the underside of the concrete and weaken it a bit. Manufacturers of concrete screws include Simpson and Powers. Before using these screws one is well advised to consult the catalogs that describe how much embedment into concrete is necessary and how far screws need to be from the edge of concrete as well as several other factors. You may want to consult a contractor or professional engineer about these rather technical issues to assure that your efforts are not wasted.

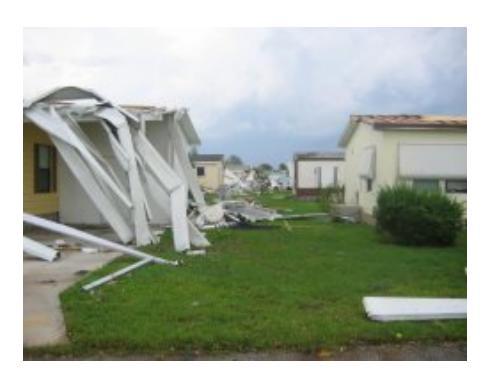
Metal panels on carport roofs frequently break loose in strong winds

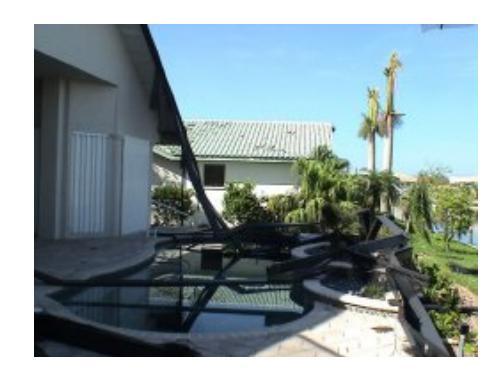
This used to be a nice screen pool enclosure before the hurricane blew through

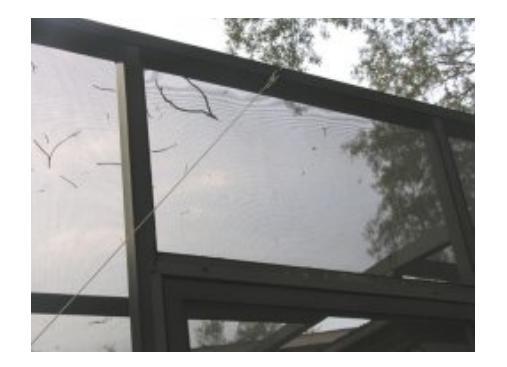
Diagonal wire cable braces should be installed as close as possible to the columns to avoid buckling the members. Bear in mind that these diagonals only work in one direction, the tension direction. Note that only a single bolt connects the cable to the frame.

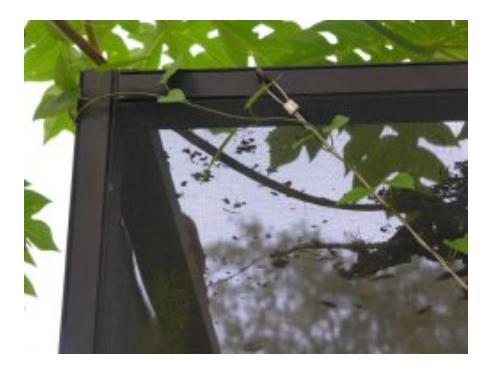
When the wind blows from right to left, this cable will be pulled tight trying to keep the screen enclosure from blowing over. It will pull down on the top member. At the same time, the wind forces on the screen face to the right will apply a lot of compressive forces to the top member and it will likely buckle from a combination of the compression and the bending caused by the pull of the cable. Some manufacturers make triangular brackets that are screwed onto the corner and allow the cable to be attached directly in line with the corner.

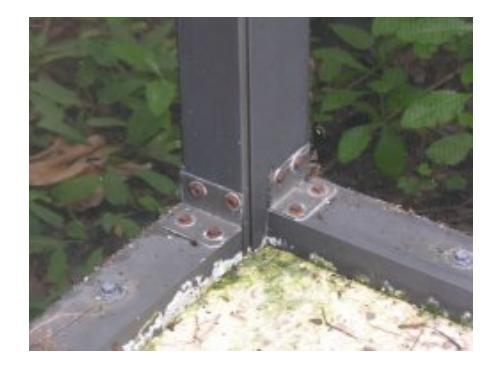
Typical anchorage of corner column in older screen enclosures - this is a very weak connection for resisting either uplift or bending. The white deposit around the heads of screws is aluminum oxide, the rust of aluminum which indicates greatly weakened connections.

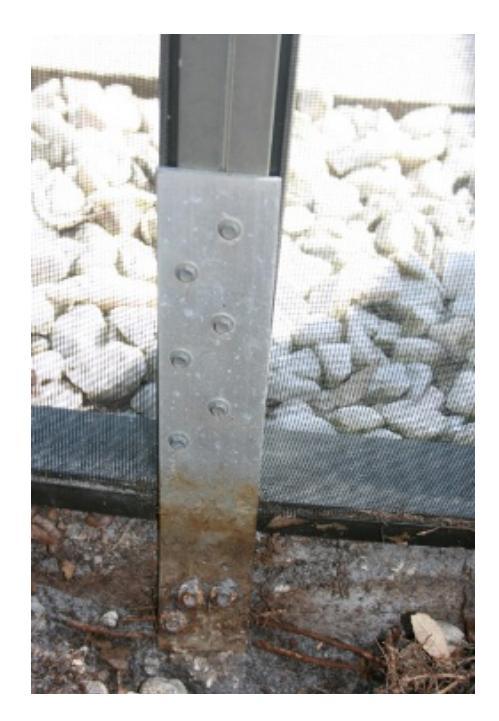
This shows an attempt to hold a post to concrete perimeter beam below. (click image for larger version)

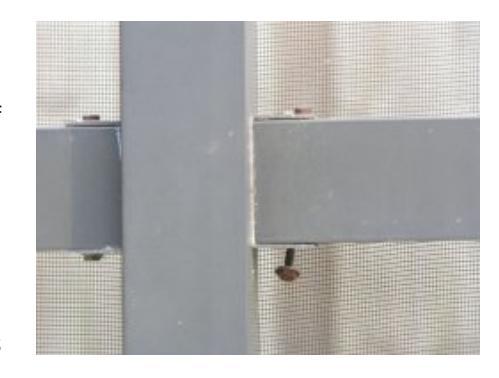
Replacing screws that are backing out, rusted, or broken can help you get what

Reviews of enclosure failures suggest that the simplest retrofits that may do some good include improving the anchorage of the columns to the concrete deck and installing additional diagonal bracing. In a lot of cases, the screws begin to rust almost immediately and loose considerable strength. Replacing rusted screws with slightly larger stainless steel screws is another way to try and get the most out of the structure you have in your existing screen enclosure. Using stainless steel screw strength you can out of your existing is highly recommended, but they cost a frame fair amount more than one made of steel.
